Manhole Inspection Summary

Manhole # S35Q__026MH

Insp Date: **2/12/08 11:27 AM**

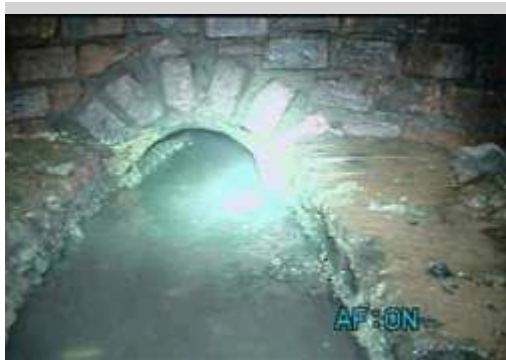
Defect 1

Condition: ☐ Sound ☐ Cracked ☐ Root Intrusion ☐ Deteriorated ☐ Leaks ☒ **Debris**

Bench and Channel Debris

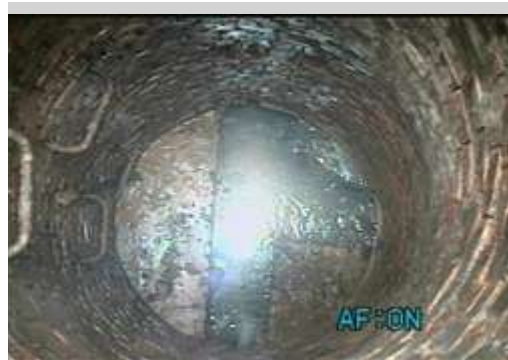
Defect 2

Infiltration: ☐ None ☐ Joint ☐ Cracks ☐ Mortar ☐ Roots ☒ **Wall**

Coroded Steps, Barrel Infiltration

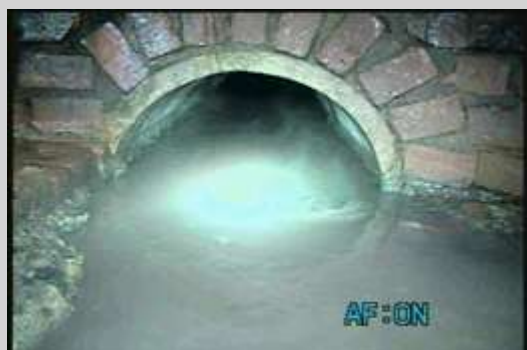
12 O'Clock Outflow

10 in. Circular Gravity Sewer
Pipe Out @ 12 O'Clock

Invert Depth: 11.00 (ft.) Flow Characteristics: **Fast**

Deposits: ☒ None ☐ Mud ☐ Sludge ☐ Debris ☐ Grease

Infiltration: **None** Pipe Seal Cond: **Unknown**

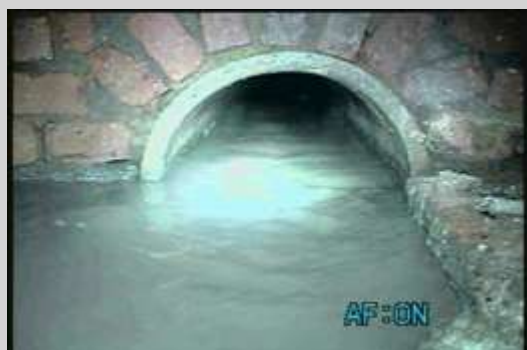
3 O'Clock Inflow

10 in. Circular Gravity Sewer
Pipe In @ 3 O'Clock

Invert Depth: 10.80 (ft.) Flow Characteristics: **Fast**

Deposits: ☒ None ☐ Mud ☐ Sludge ☐ Debris ☐ Grease

Infiltration: **None** Pipe Seal Cond: **Unknown**

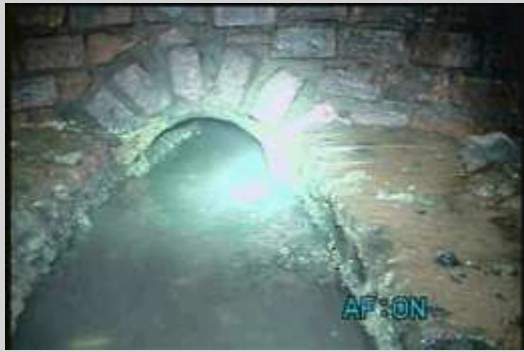
6 O'Clock Inflow

10 in. Circular Gravity Sewer
Pipe In @ 6 O'Clock

Invert Depth: 10.50 (ft.) Flow Characteristics: **Fast**

Deposits: ☐ None ☐ Mud ☐ Sludge ☐ Debris ☒ **Grease**

Silt Depth: 2 (in.) Deposits Extent: **Light**

Infiltration: **None** Pipe Seal Cond: **Unknown**
